# Manhole Inspection Summary

Manhole # S27G\_\_009MH

Insp Date: **5/21/08 9:28 AM**

**Location** Address: **8 Booth st**

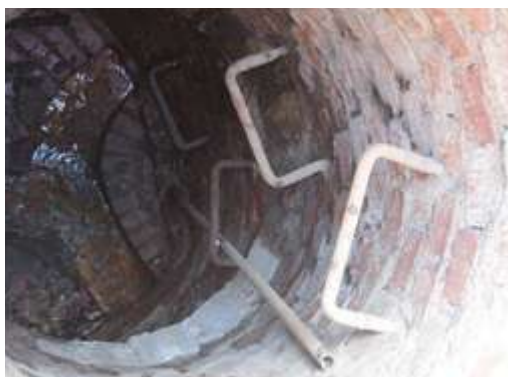
misc

debri on bench

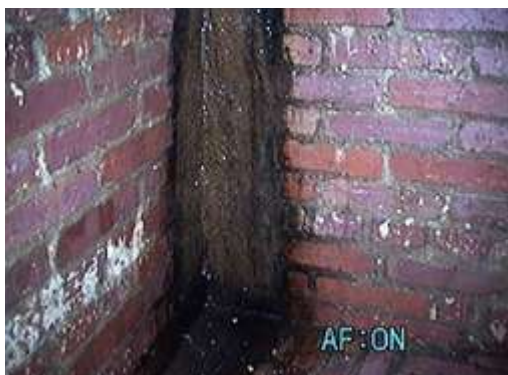
Infiltration

barrel infiltration

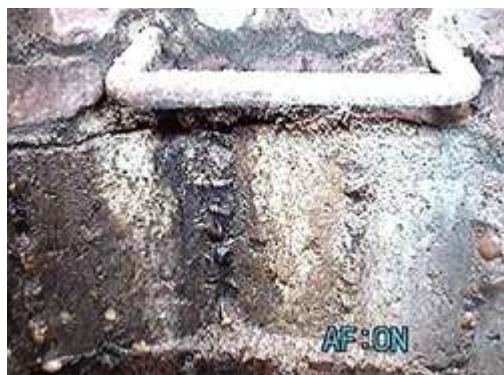
Infiltration 2

infiltration barrel

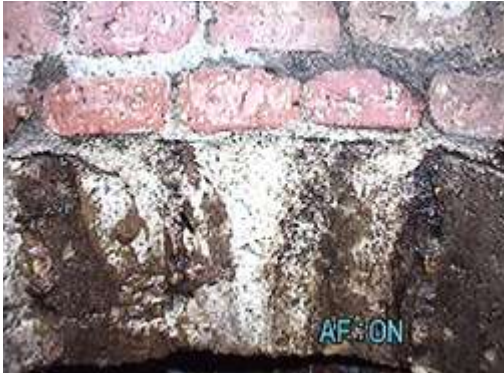
Infiltration 3

active infiltration barrel and corbel connect

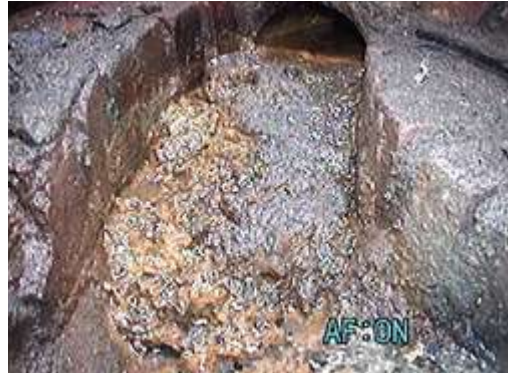
Defect 5

debris in channel

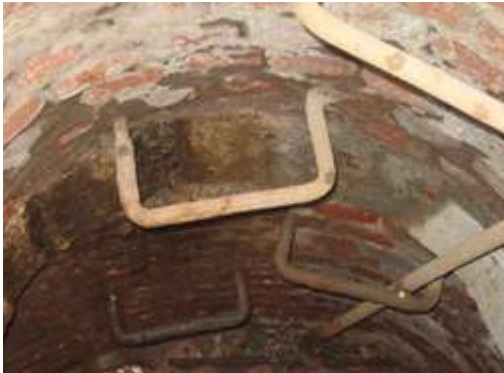
Defect 4

active infiltration corbel

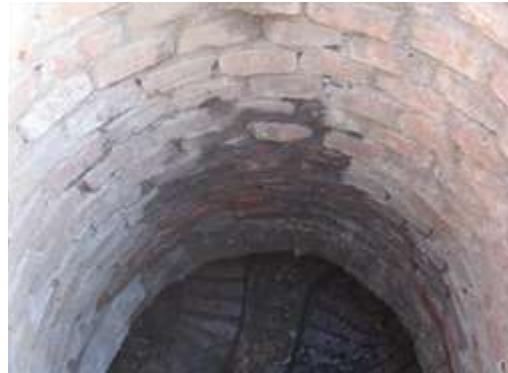
Defect 2

active infiltration corbel

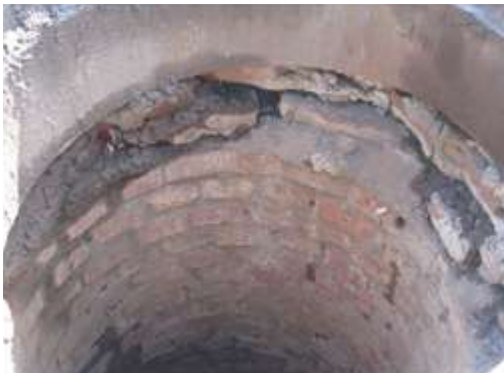
Defect 6

Offset, frame leak-sheeting evidence

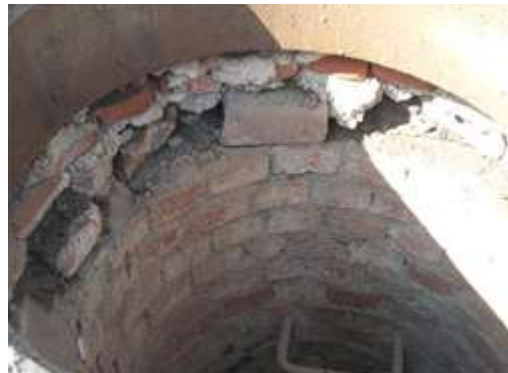
Defect 1

chimney-missing, loose bricks missing mortar

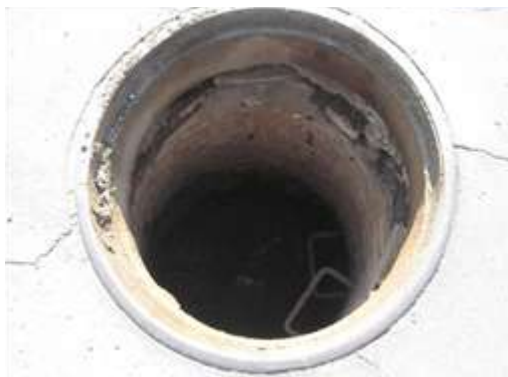
### Defect 5

Frame leaks, evidence of chimney infiltration

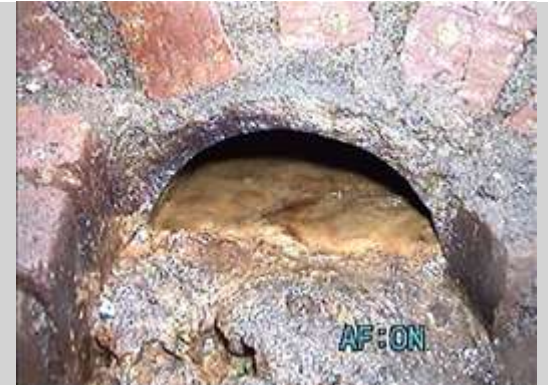
8 O'Clock Inflow

Deposits: ☐ None ☐ Mud ☒ ~~Sludgy~~ ☐ Debris ☐ Grease

Silt Depth: **5** (in.) Deposits Extent: **Heavy**
